ADVANCED COMPOSITE ELEVATOR FOR BOEING 727 AIRCRAFT VOLUME 2—FINAL REPORT

Boeing Commercial Airplane Company
P.O. Box 3707, Seattle, WA 98124

CONTRACT NAS1-14952
NOVEMBER 1980

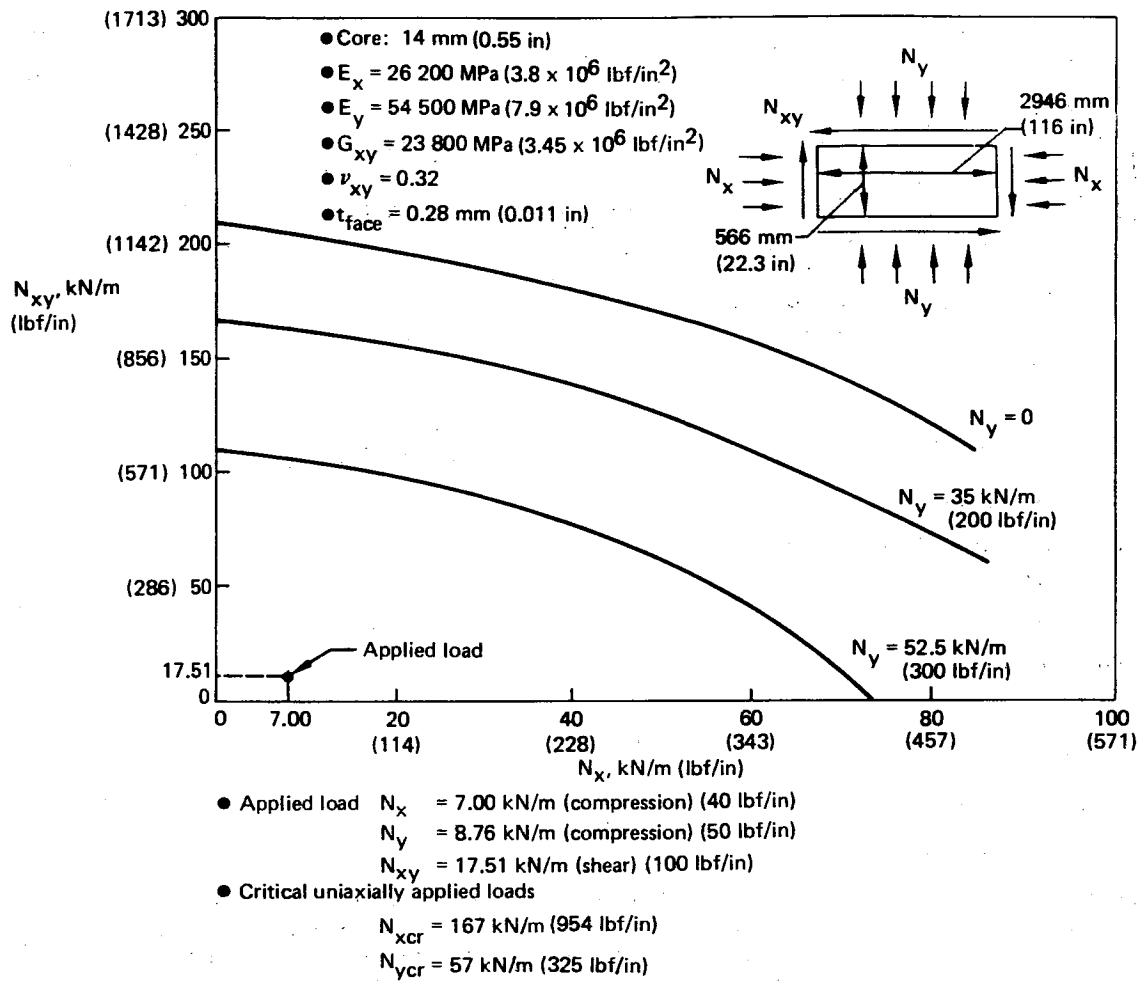
Figure 48. Interaction Curves—Outboard Skin Panel

Interaction curves for orthotropic sandwich panels loaded in biaxial compression and shear were developed from the buckling analysis (ref 6) for the three main unsupported skin panels on each surface of the elevator. These curves are shown in Figures 48, 49, and 50.

The applied loads shown on each of the curves are the maximum ultimate biaxial end loads and shear load for the elevator surface panels as obtained from the ATLAS solution. A comparison between the applied loads and the analytical curves indicates that large margins exist for buckling in all three panel areas.

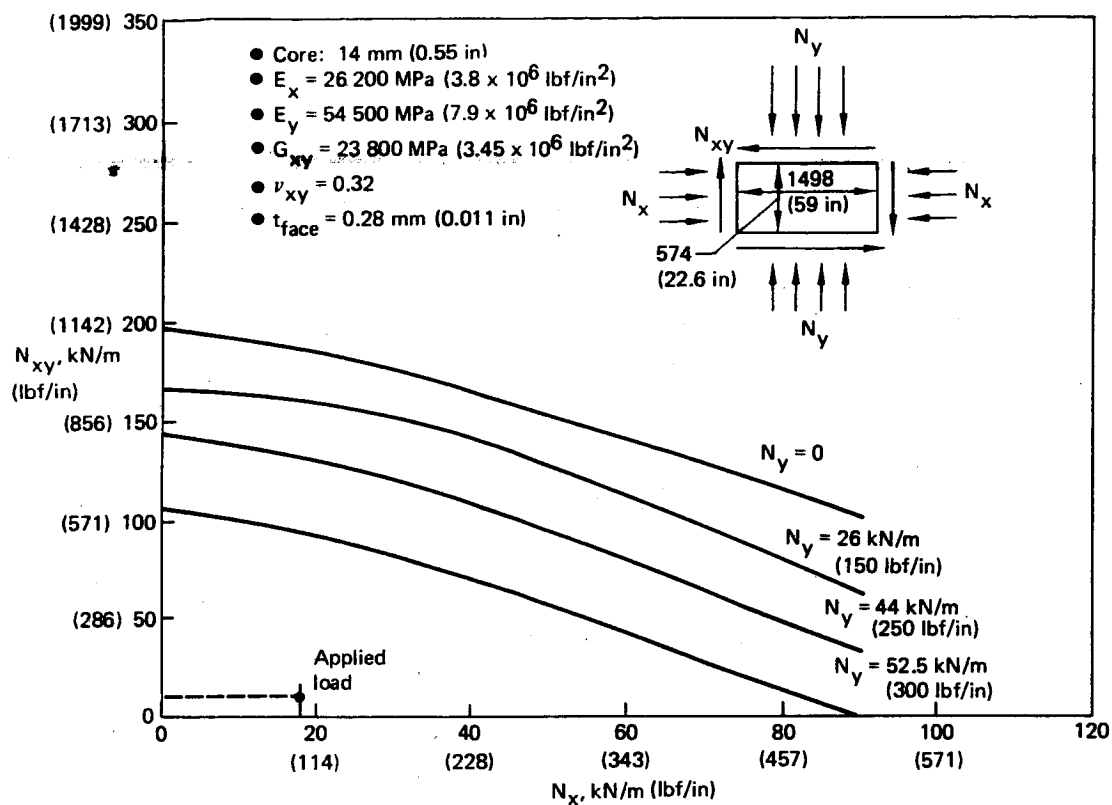
- Applied load $N_x = 17.51\text{ kN/m}$ (compression) (100 lbf/in)
 $N_y = 3.50\text{ kN/m}$ (compression) (20 lbf/in)
 $N_{xy} = 8.76\text{ kN/m}$ (shear) (50 lbf/in)

- Critical uniaxially applied compression load

$$N_{ycr} = 70\text{ kN/m} (400\text{ lbf/in})$$

Figure 49. Interaction Curves—Skin Panel Between Actuator Rib and Transition Rib

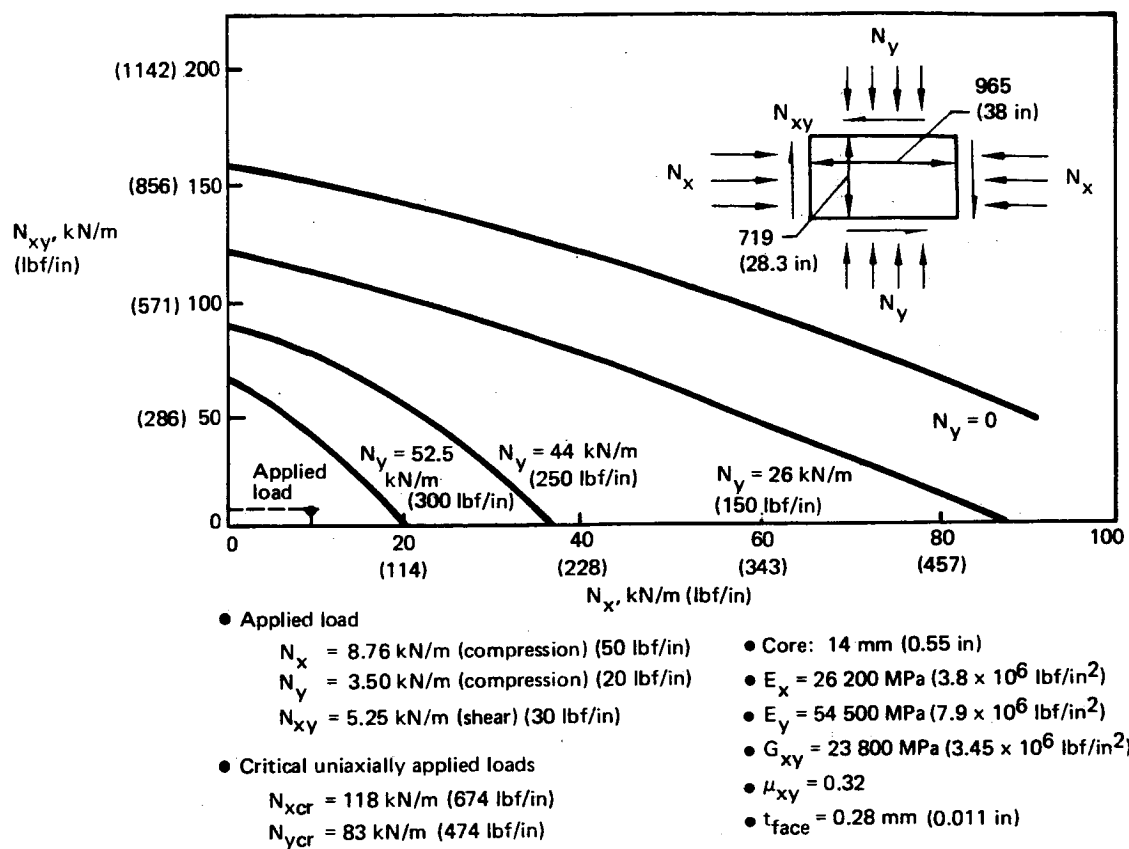
Figure 50. Interaction Curves—Inboard Skin Panel

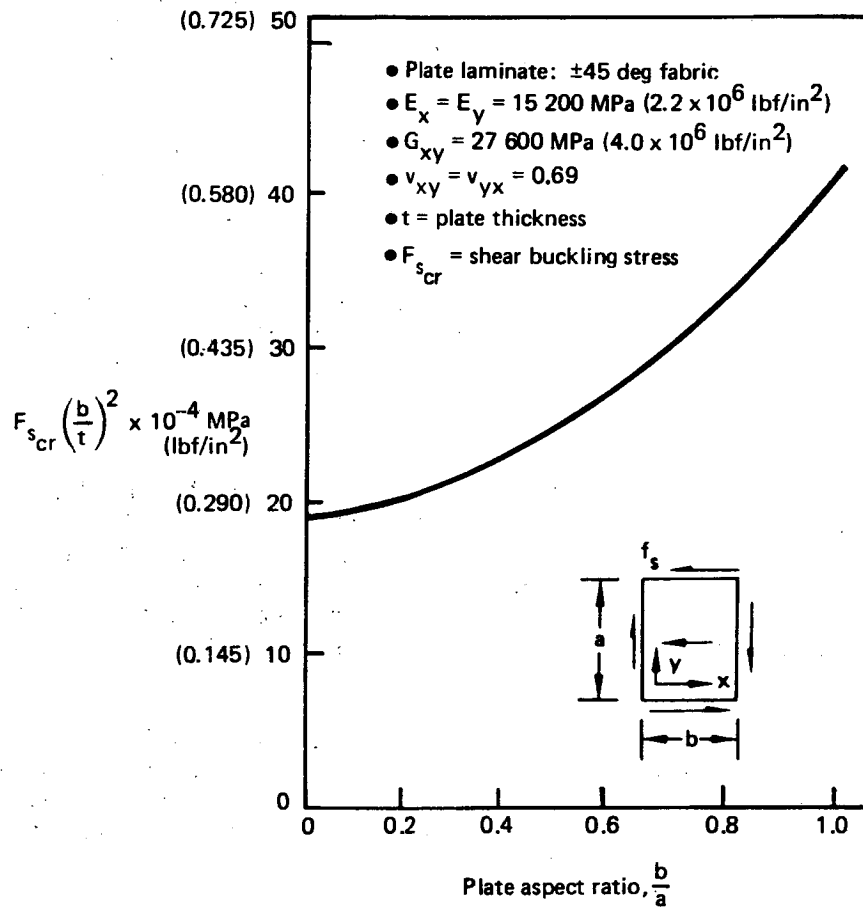
Figure 51. Shear Buckling Versus Plate Aspect Ratio—Laminate Material

The front and rear spar webs (+45-deg fabric laminates) were designed to be shear-resistant to limit load. The spar webs were analyzed for shear buckling using the analytical procedure presented in Reference 7. A typical analytical curve is shown in Figure 51. The "a" and "b" dimensions were defined as the spar web height and stiffener spacing, respectively. Due to the low shear strains, large margins existed for all shear web panels.

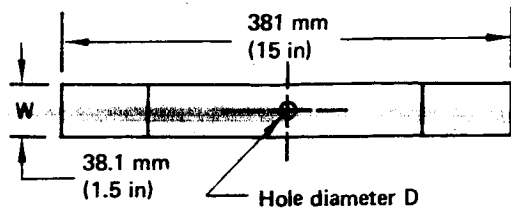
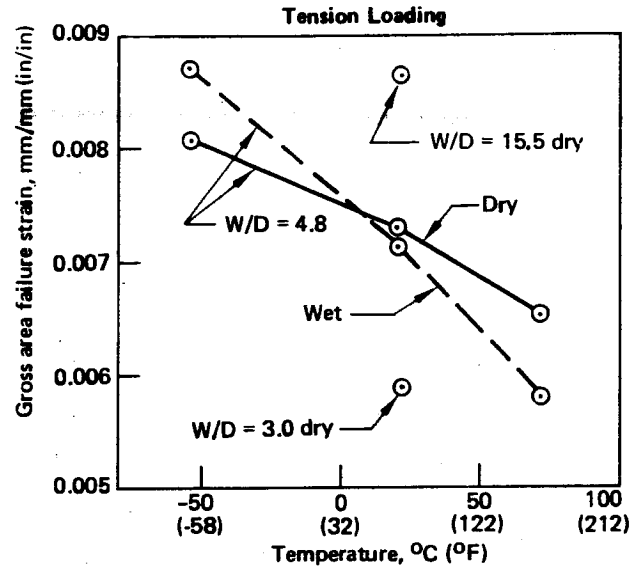
- 12 plies of fabric
- ± 45 -deg orientation
- Extensional modulus, $E = 2.07 \times 10^4$ MPa
(3.0×10^6 lbf/in²)
- Hole diameter
 - $D_1 = 7.95$ mm (0.313 in), $W/D = 4.8$
 - $D_2 = 2.46$ mm (0.097 in), $W/D = 15.5$
 - $D_3 = 12.7$ mm (0.500 in), $W/D = 3.0$
- Data from NASA test 1, Appendix C, Volume 2

Figure 54. Effect of Moisture, Temperature, and W/D on Tension Failure Strains of ± 45 -deg Fabric Laminate Coupons

Figures 54 through 57 present the effects of temperature and moisture on failure strains of +45-deg and +45/0/90-deg fabric laminates with various ratios of width to hole diameter. The test results point out the influence that temperature and moisture have on +45-deg compression-loaded coupons due to their dependency on resin properties.

Figures 58 and 59 present the effects of temperature, moisture, and hole diameter on rail shear tests for +45-deg and +45/0/90-deg fabric laminates. The rail shear results for the +45-deg laminate indicate relative insensitivity to temperature and moisture. This result is consistent with the tension- and compression-tested coupons of the +45/0/90-deg laminate (see figs. 55 and 57), since both test configurations are fiber controlled. The results for the +45/0/90-deg laminate indicate a larger sensitivity to moisture and temperature because this laminate under shear loading is more resin dependent. This result is consistent with the tension and compression tests of the +45-deg laminate (see figs. 54 and 56).

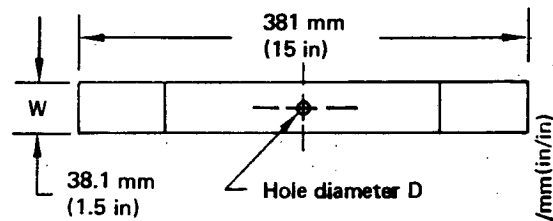
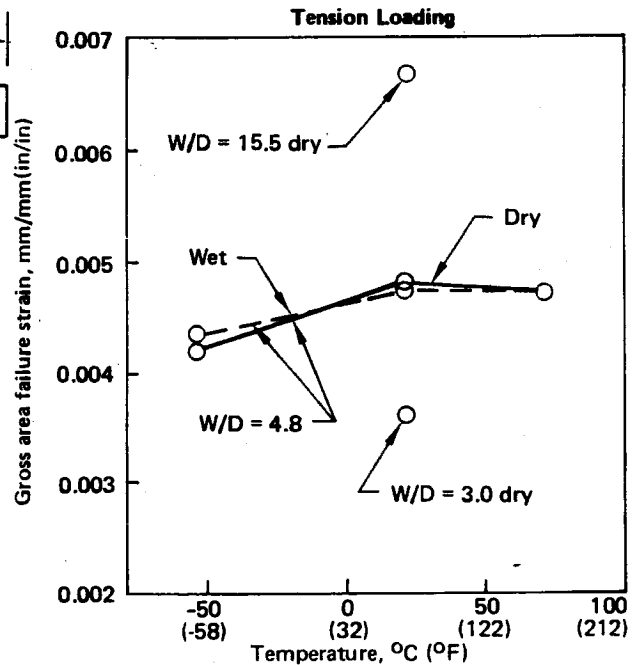
- 12 plies of fabric
- $\pm 45/0/90$ -deg orientation
- Extensional modulus, $E = 4.62 \times 10^4$ MPa
(6.7×10^6 lbf/in²)
- Hole diameter
 - $D_1 = 7.95$ mm (0.313 in), $W/D = 4.8$
 - $D_2 = 2.46$ mm (0.097 in), $W/D = 15.5$
 - $D_3 = 12.7$ mm (0.500 in), $W/D = 3.0$
- Data from NASA test 1, appendix C

Figure 55. Effect of Moisture, Temperature, and W/D on Tension Strains of $\pm 45/0/90$ -deg Fabric Laminate Coupons

Figure 71 compares the results of the open-hole tests from Figure 55 with the filled-hole test data from Test 4. These results indicate that gross area failure strains are similar for the open hole, fastener-filled hole, and fastened-clip configurations for the same width-to-fastener-diameter ratio.

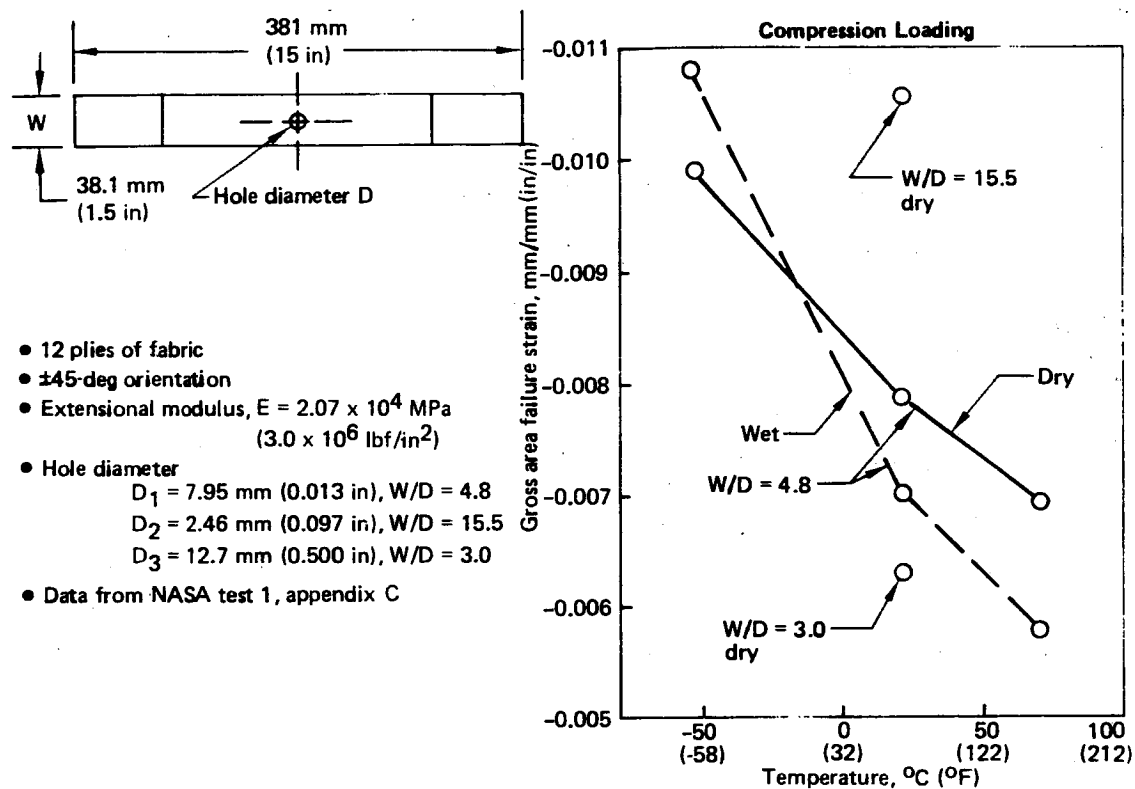
Figure 56. Effect of Moisture, Temperature, and W/D on Compression Failure Strains of ±45-deg Fabric Laminate Coupons

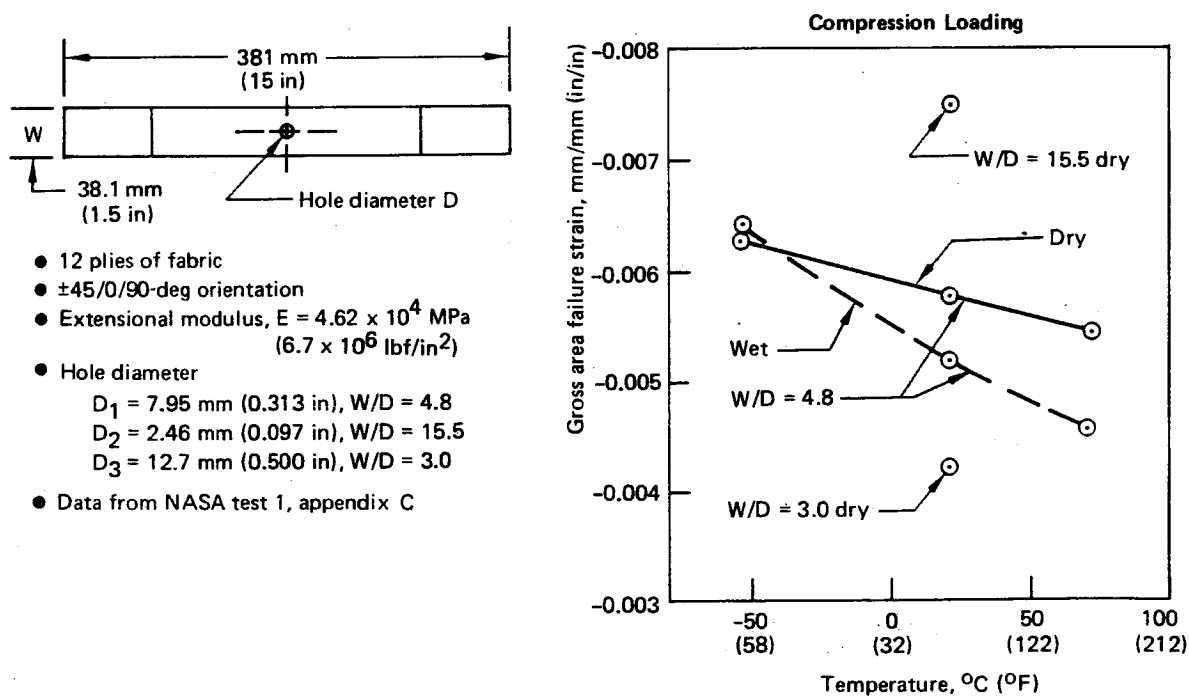
Figure 57. Effect of Moisture, Temperature, and W/D on Compression Failure Strains of ±45/0/90-deg Fabric Laminate Coupons

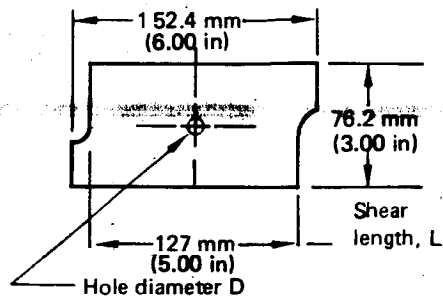
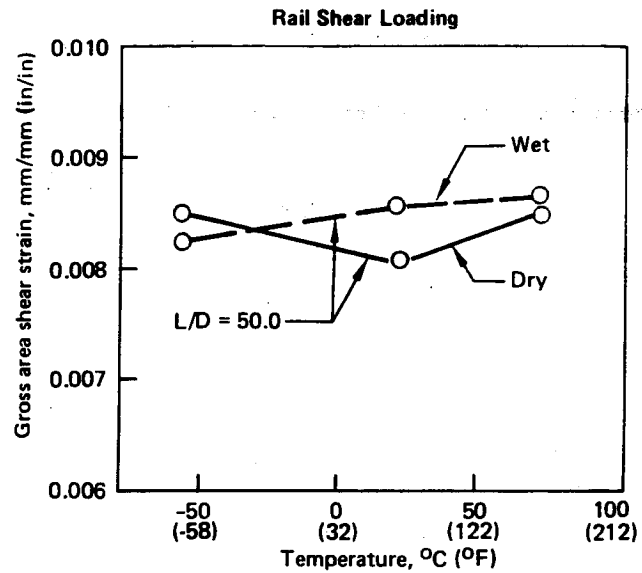
- 12 plies of fabric
- ± 45 -deg orientation
- Shear modulus, $G = 2.93 \times 10^4$ MPa
(4.25×10^6 lbf/in²)
- Hole diameter $D = 2.54$ mm (0.100 in),
 $L/D = 50.0$
- Data from NASA test 1, appendix C

Figure 58. Effect of Moisture, Temperature, and Hole Diameter on Rail Shear Test Results for ± 45 -deg Fabric Laminate

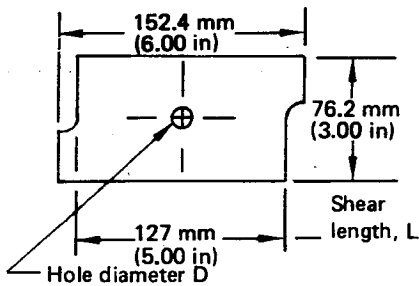
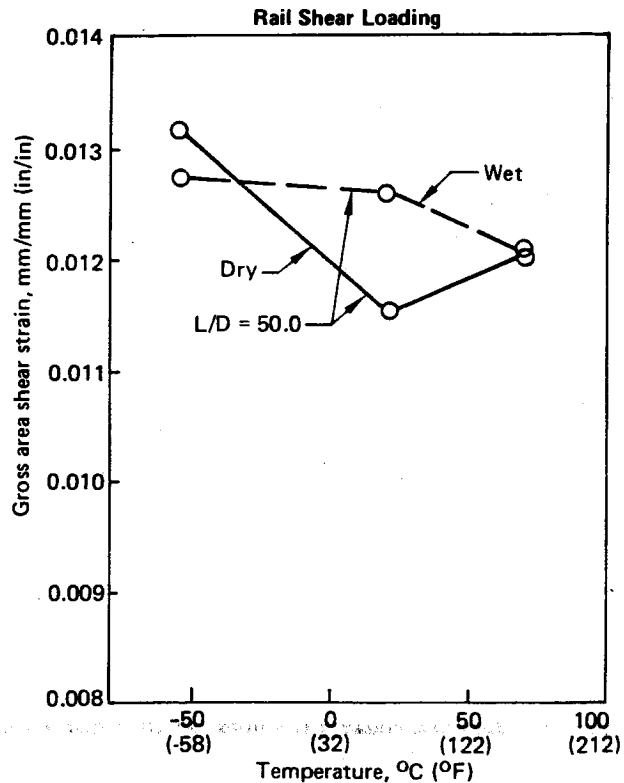
- 12 plies of fabric
- $\pm 45/0/90$ -deg orientation
- Shear modulus, $G = 1.79 \times 10^4$ MPa
(2.6×10^6 lbf/in²)
- Hole diameter $D = 2.54$ mm (0.100 in),
 $L/D = 50.0$
- Data from NASA test 1, appendix C

Figure 59. Effect of Moisture, Temperature, and Hole Diameter on Rail Shear Test Results for $\pm 45/0/90$ -deg Fabric Laminate

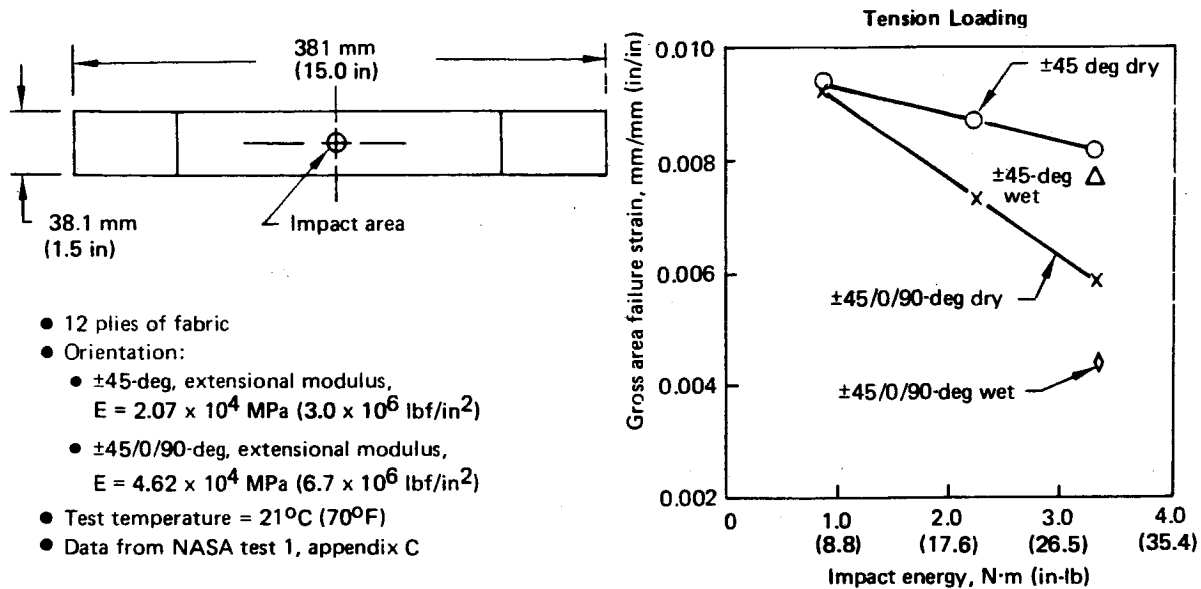
Figure 60. Effect of Moisture and Impact on Tension Failure Strains of ± 45 -deg and $\pm 45/0/90$ -deg Fabric Laminate Coupons

Figure 60 presents the effects of impact and moisture on tension failure strains of +45-deg and +45/0/90-deg fabric laminates. Figure 61 shows similar data for compression failure strains.

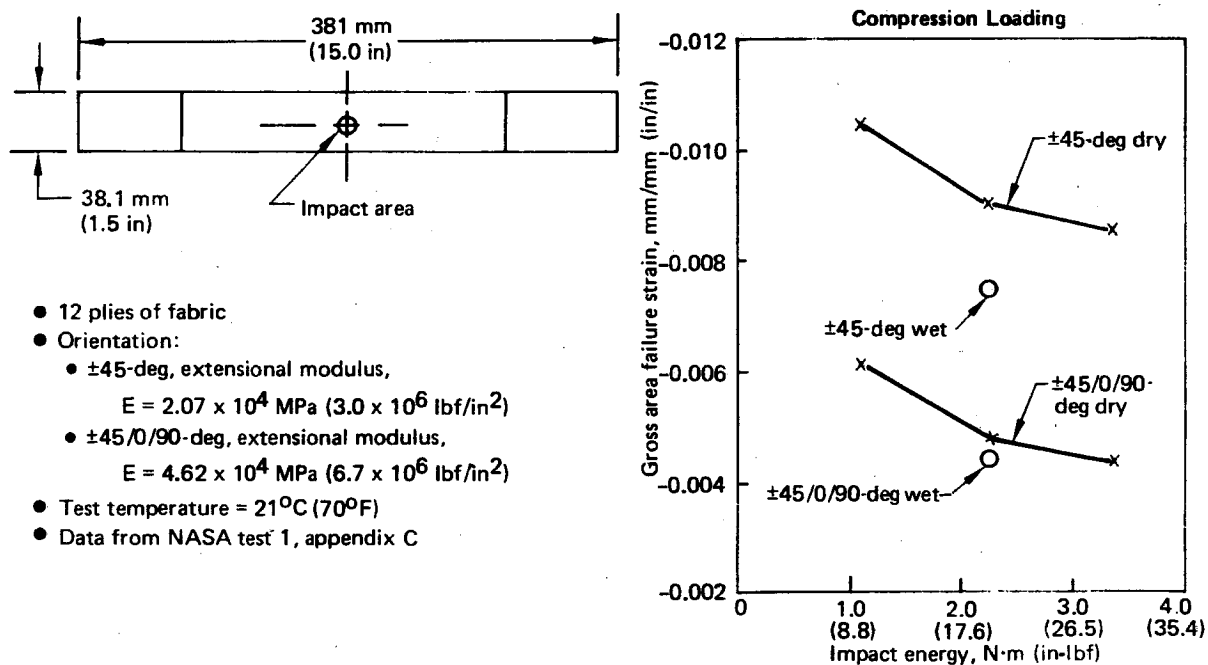
Figure 61. Effect of Moisture and Impact on Compression Failure Strains of ± 45 -deg and $\pm 45/0/90$ -deg Fabric Laminate Coupons

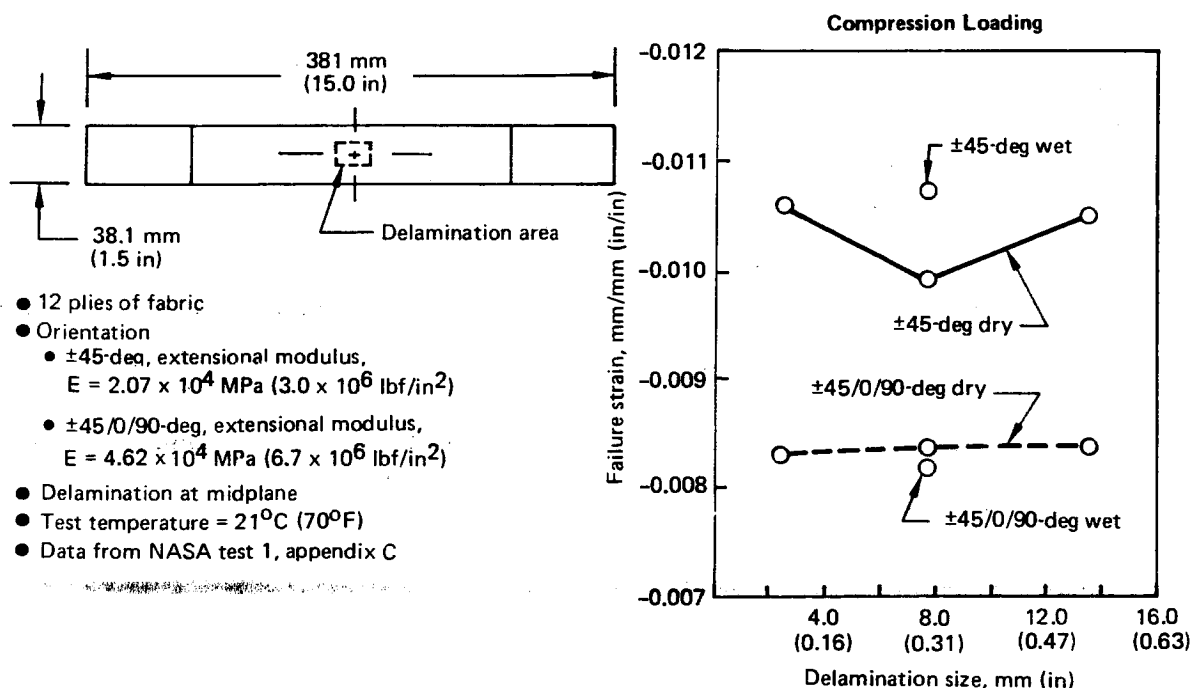
Figure 62. Effect of Moisture and Delamination Size on Compression Failure Strains of ± 45 -deg and $\pm 45/0/90$ -deg Fabric Laminate Coupons

Figure 62 presents the effect of delaminations on ± 45 -deg and $\pm 45/0/90$ -deg fabric laminates loaded in compression. These test results, when compared to the results shown in Figure 64, indicate that delaminations of the size tested, located at the midplane of a 12-ply laminate, have minimal effect on compression failure strains.

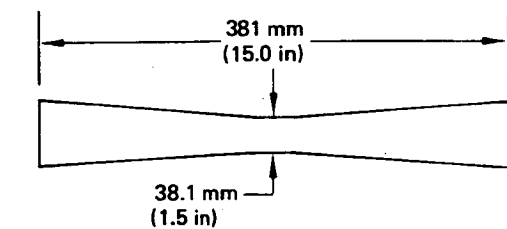
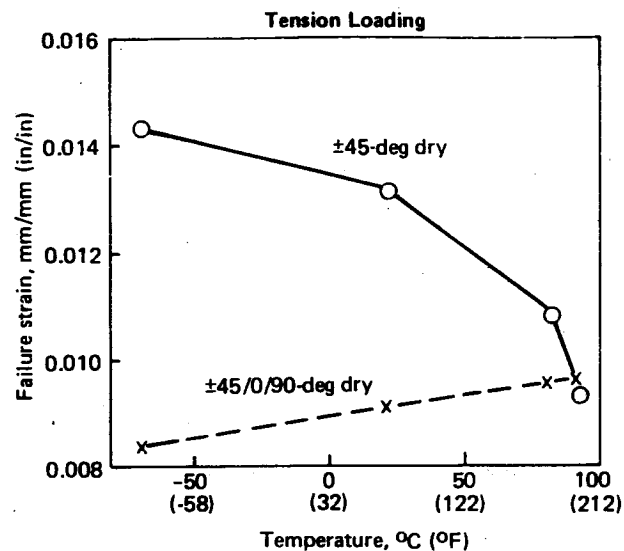
- 12 plies of fabric
- Orientation:
 - ± 45 -deg, extensional modulus,
 $E = 2.07 \times 10^4$ MPa (3.0×10^6 lbf/in²)
 - $\pm 45/0/90$ -deg, extensional modulus,
 $E = 4.62 \times 10^4$ MPa (6.7×10^6 lbf/in²)
- Data from Boeing test 7313-16, appendix C

Figure 63. Effect of Temperature on Tensile Failure Strains of ± 45 -deg and $\pm 45/0/90$ -deg Fabric Laminate Coupons

Figure 63 and 64 present effects of temperature on tension and compression failure strains of ± 45 -deg and $\pm 45/0/90$ -deg laminates for coupons with no stress concentrations. The results for the ± 45 -deg laminate point out the significant temperature influence on coupons that are resin dominated.

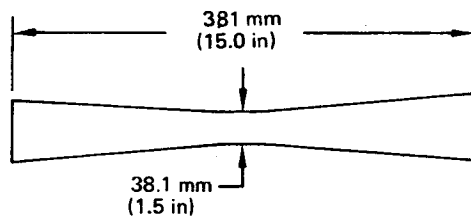
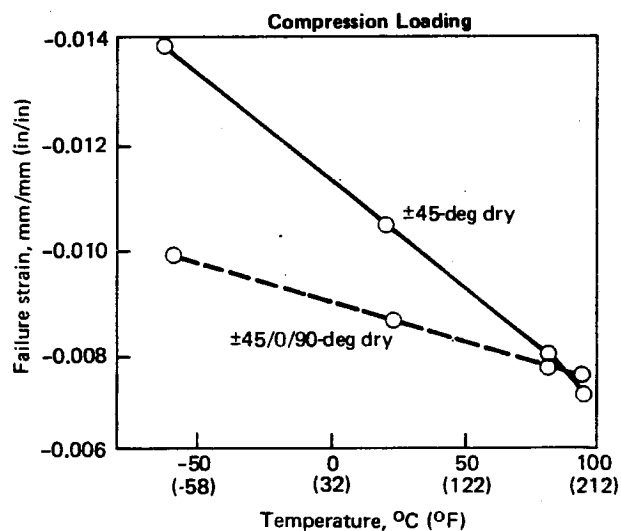
- 12 plies of fabric
- Orientation:
 - ± 45 -deg extensional modulus,
 $E = 2.07 \times 10^4$ MPa (3.0×10^6 lbf/in²)
 - $\pm 45/0/90$ -deg, extensional modulus,
 $E = 4.62 \times 10^4$ MPa (6.7×10^6 lbf/in²)
- Data from Boeing test 7313-16, appendix C

Figure 64. Effect of Temperature on Compression Failure Strains of ± 45 -deg and $\pm 45/0/90$ -deg Fabric Laminate Coupons

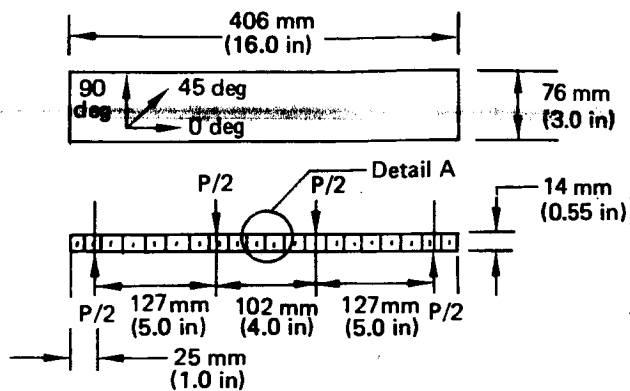
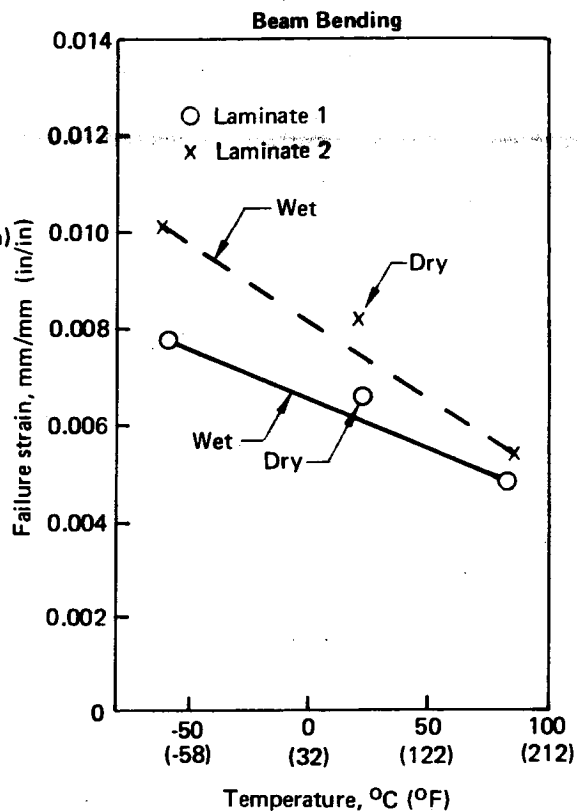
- Tool surface ply layup
 - Laminate 1—0-deg tape, ± 45 -deg fabric, $E = 5.38 \times 10^4$ MPa (7.8×10^6 lbf/in²)
 - Laminate 2—90-deg tape, ± 45 -deg fabric, $E = 2.62 \times 10^4$ MPa (3.8×10^6 lbf/in²)
- Tape direction same for both faces
- Tool surface in compression
- Detail A

- Data from Boeing test 7313-36, appendix C

Figure 65. Effect of Temperature and Moisture on Failure Strains of Four-Point Beam-Bending Specimens—Tool Surface in Compression

The design value strains used for tension and compression were obtained from the Boeing-funded four-point beamsandwich panel tests (see figs. 65 and 66, sec. 4.2.1). A correction factor (DVR) of 0.75 (fig. 42) was used to reduce the test data to the "B" basis.

Figures 65 and 66 present basic compression strengths of the elevator skin panels. These test results indicate the differences in compression strength between the tool and bag sides and between the high- and low-modulus directions of the honeycomb skin panels.

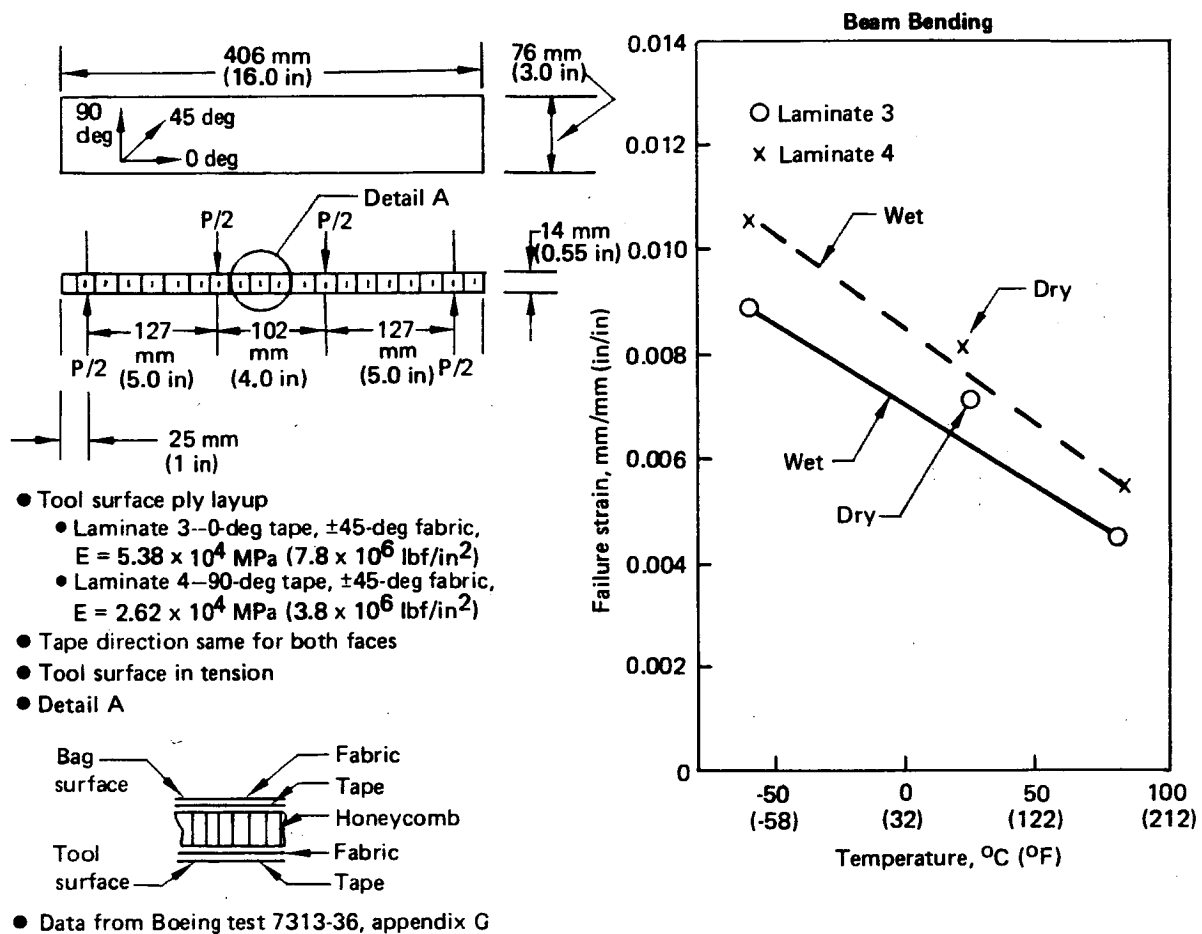
Figure 66. Effect of Temperature and Moisture on Failure Strains of Four-Point Beam-Bending Specimens—Tool Surface in Tension

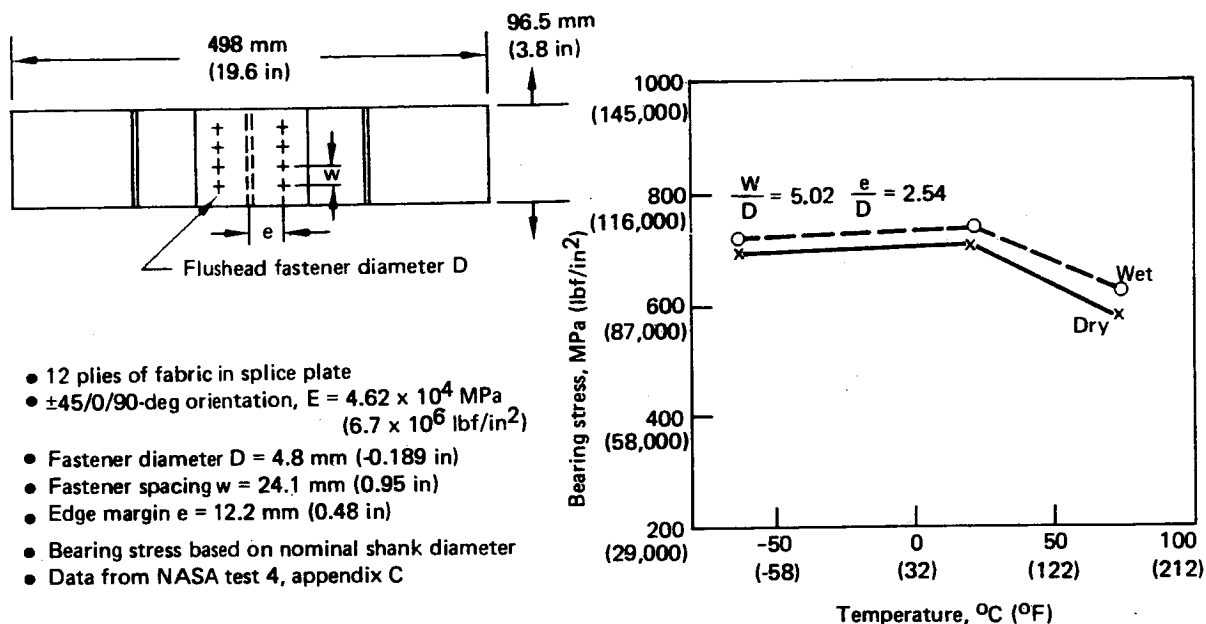
Figure 68. Effect of Moisture and Temperature on Fastener Bearing Stress

The design value bearing stress at 82°C (180°F) was obtained from the ancillary test structural element tests (see fig. 68, sec. 4.2.3.1). A DVR of 0.74 was used to reduce the test data to the "B" basis.

Figure 68 shows the effects of moisture and temperature on fastener bearing stresses, Figure 69 shows the effect of fastener spacing on bearing stresses, and Figure 70 shows the effect of fastener edge margin on bearing stresses.

Critical bearing stress = 703 MPa (102,000 lbf/in²)
(see fig. 68)

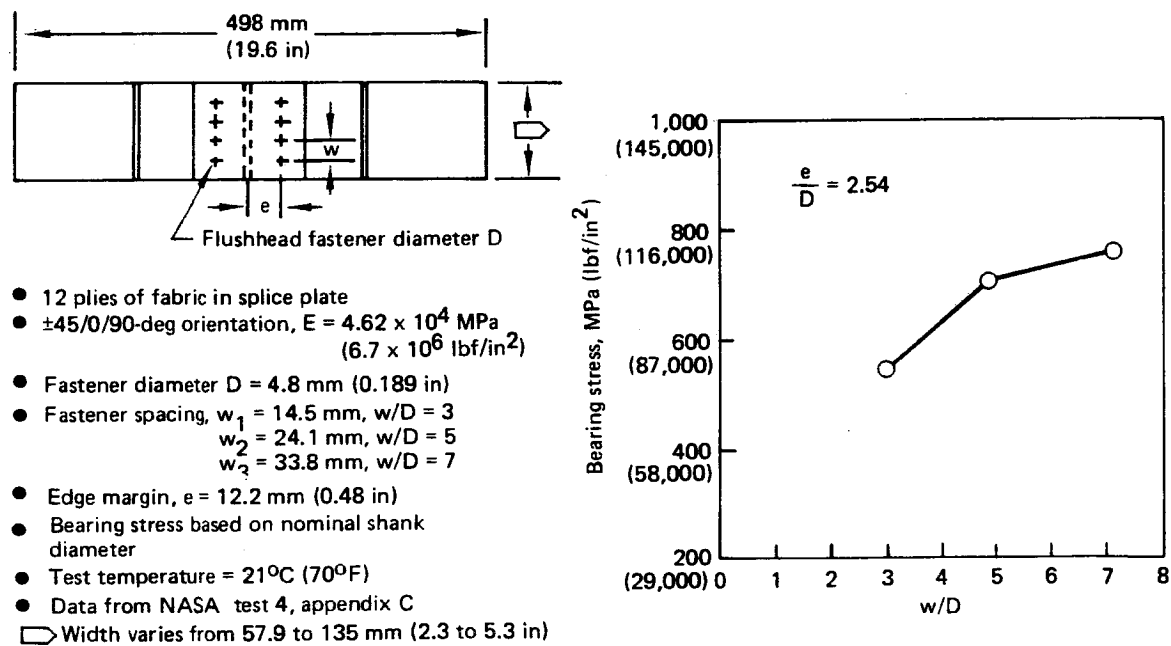
Figure 69. Effect of Fastener Spacing (W/D) on Bearing Stress

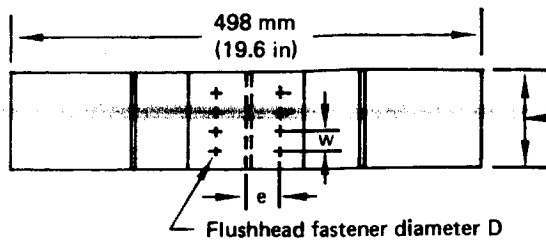
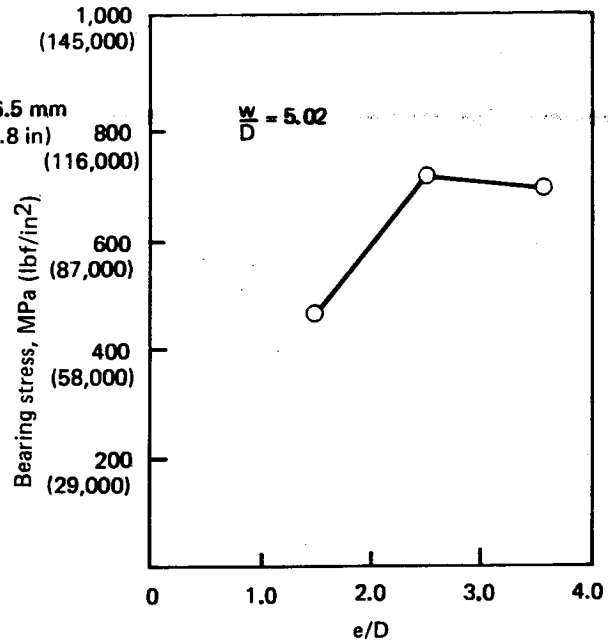
- 12 plies of fabric in splice plate
- $\pm 45/0/90$ -deg orientation, $E = 4.62 \times 10^4 \text{ MPa}$
($6.7 \times 10^6 \text{ lbf/in}^2$)
- Fastener diameter $D = 4.8 \text{ mm}$
- Fastener spacing, $w = 24.1 \text{ mm}$
- Edge margin, $e_1 = 7.4 \text{ mm}$ ($\frac{e}{D} = 1.54$)
 $e_2 = 12.2 \text{ mm}$ ($\frac{e}{D} = 2.54$)
 $e_3 = 17.0 \text{ mm}$ ($\frac{e}{D} = 3.54$)
- Bearing stress based on nominal shank diameter
- Test temperature = 21°C (70°F)
- Data from NASA test 4, appendix C

Figure 70. Effect of Edge Margin (e/D) on Bearing Stress

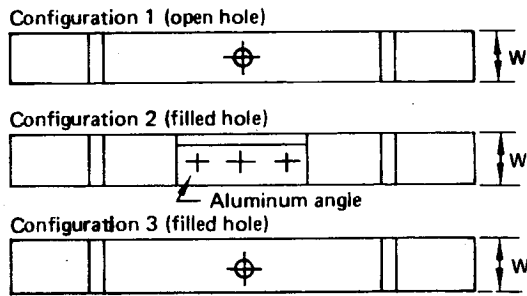
- Configuration 1 data from Figure 55
- Configuration 2 from test 4, appendix C
- Configuration 3 from test 4, appendix C
- $E = 4.62 \times 10^4$ MPa (6.7×10^6 lbf/in²)
- Test temperature = 21°C (70°F)
- Dry conditions

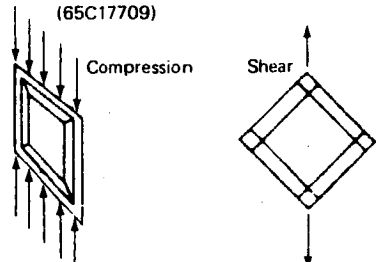
Figure 72. Elevator Subcomponent Test Plan

±45	521.0 (20.5) x 521.0 (20.5)	RT, dry	4	-	Design verification
10	Honeycomb panel stability test (65C17709)

90/±45 2-ply faces honeycomb	Com- pression 597.0 (23.5) x 610.0 (24.0) Shear 610.0 (24.0) x 610.0 (24.0)	RT, dry RT, wet RT, dry damaged RT, dry RT, wet RT, dry damaged	3 2 2 3 2 2	- - - - - -	Design verification
12	Panel edge shear and bending test (65C17710)

The subcomponent test plan is shown in Figure 72. The test results from this phase of the program were used to verify the design and durability of specific subcomponents prior to fabrication of the first elevator unit.

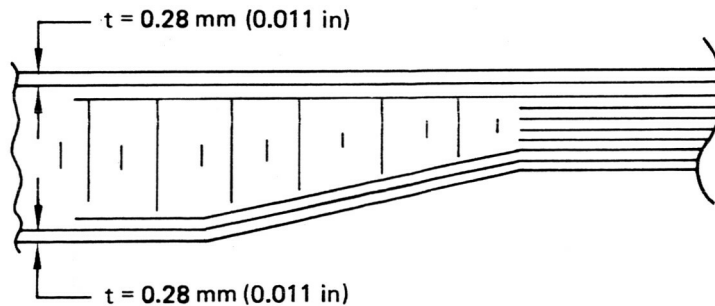
Figure 75. Cover Panel Padup Strain Calculation

Specimen Cross Section

- Average failure load = 6,405 kN (1440 lbf)
(NASA test 8, appendix C)
- Strain based on basic skin
 - Thickness, t = 0.28 mm (0.011 in)
 - Width, W = 63.5 mm (2.5 in)
 - Area, A = 35.56 mm² (0.055 in²)
 - E = 2.62×10^4 MPa (3.8×10^6 lbf/in²)
 - Strain, ϵ = $\frac{6.405 \times 1000 \times 10^6}{35.56 \times 2.62 \times 10^4 \times 10^6} = 0.00687$ mm/mm (in/in)

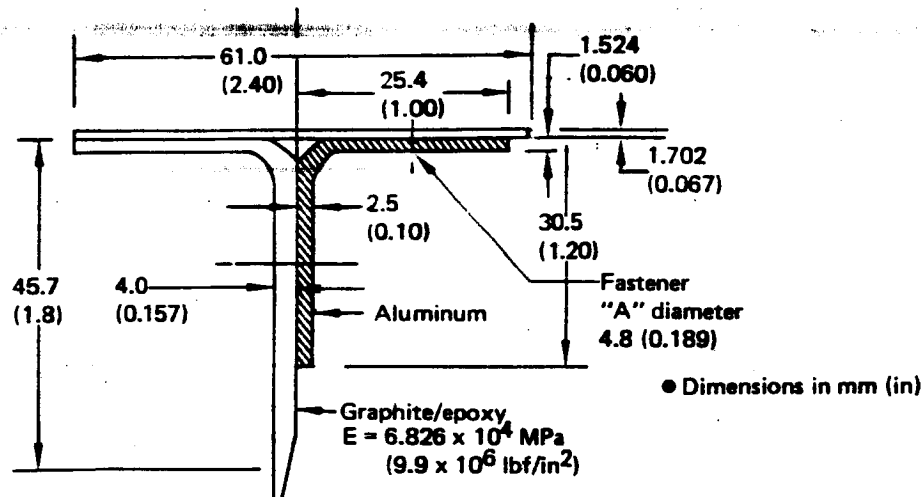
Figure 93. Front-Spar Actuator Fitting Splice Predicted Failure Load

Front Spar Actuator Fitting Splice Area, Section of Upper Chord at Failure

- At the failure section, the gross area strain is given by:

$$\epsilon_c = \frac{P_c}{A_c E_c}$$

- On the assumption that this fastener load in the 1.702 mm (0.067 in) thick graphite skin causes a bearing failure, which initiates the final failure, the critical fastener load is:

$$\text{Ratio} = \frac{0.002938}{0.0027} = 1.09$$

The calculation procedure to predict the test failure strain is presented in Figure 93. This analysis indicates that the test and predicted values are within 9%.

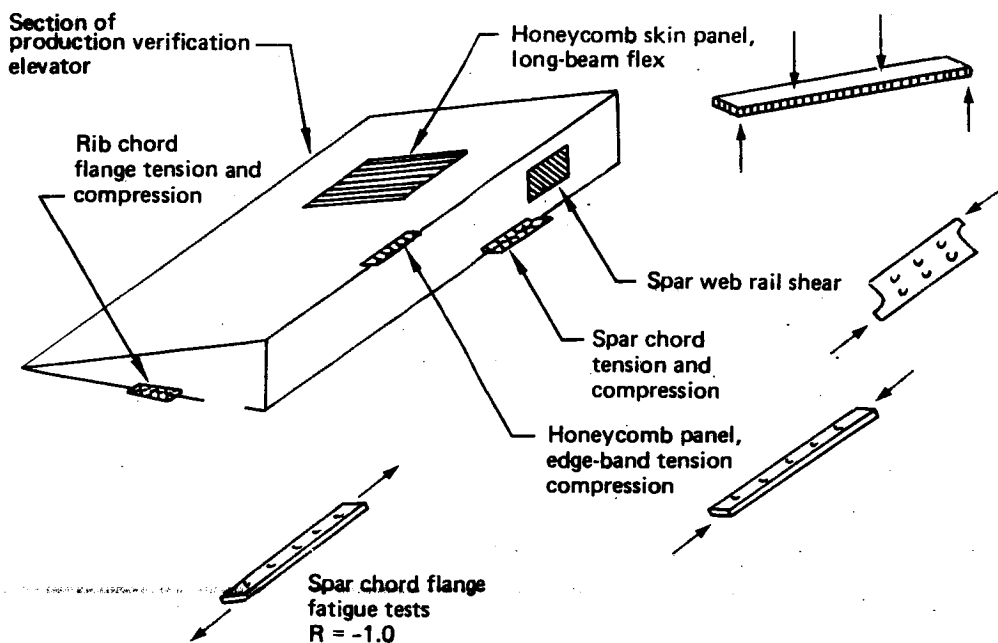
Figure 105. Production Verification Hardware Test Coupons

- Specimens taken from parts fabricated on production tools
- All tests conducted at room temperature

Tests of laminate and honeycomb coupons cut from an elevator production verification section were performed. The specimen configurations and the areas on the verification hardware from which the specimens were taken are shown in Figure 105. The test results are presented in Table 9 and, when compared with the ancillary test program coupon data, indicate that the production process produces an acceptable quality laminate. As noted in Table 9, six specimens were fatigue loaded to 500,000 cycles at $R = -1.0$ at a maximum load equal to 25% of the static ultimate capability. These specimens then were loaded statically to failure. When compared with similar specimens, the residual test results indicate that the applied cyclic loading at ambient conditions had no significant effect on the ultimate load capability of the tested configuration.

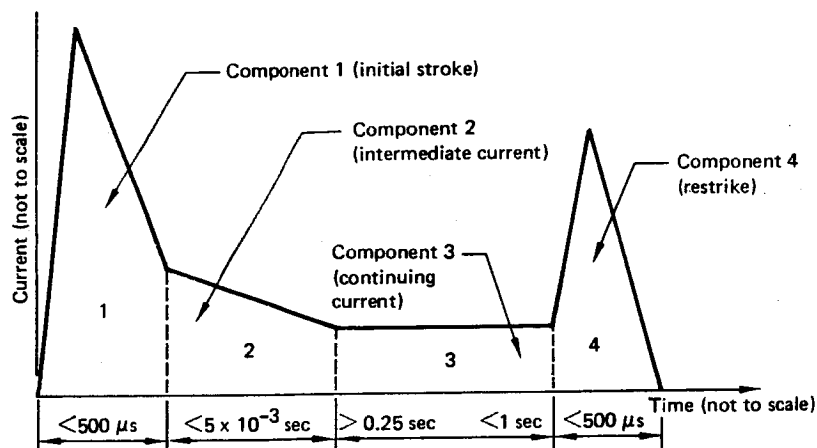
Figure 108. Zone 1B Lightning Test Waveform and Test Values Used for Testing

Test waveform	Parameter	Boeing test value
Component 1	Peak current	211,000 amps
	Action integral	$3.95 \times 10^6 \text{ amps}^2\text{-sec}$
Component 2	Average current	2,030 amps
	Charge transfer	11.2 coulombs
Component 3	Average current	621 amps
	Charge transfer	230 coulombs
Component 4	Peak current	129,000 amps
	Action integral	$0.97 \times 10^6 \text{ amps}^2\text{-sec}$

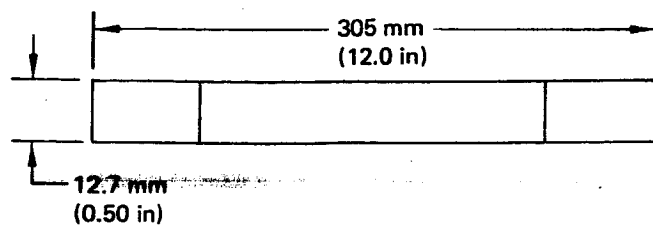
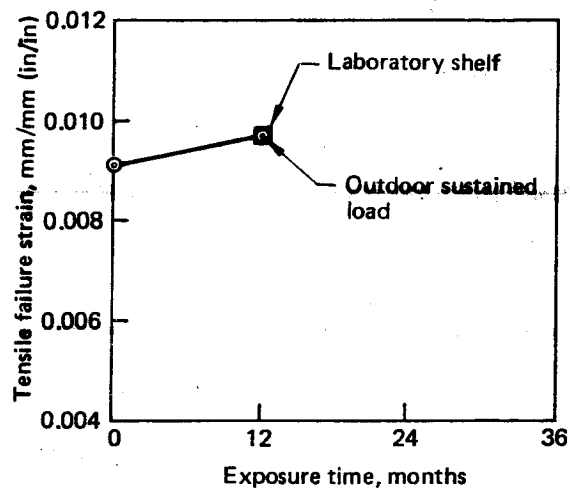
Figure 115. Tension Coupon Environmental Exposure Test Results

- 12 plies of fabric
- Orientation: ± 45 deg
- Extensional modulus, $E = 2.07 \times 10^4$ MPa (3.0×10^6 lbf/in²)
- Data from NASA Test 3, Appendix C

At present, test data have been obtained for the ± 45 -deg tension coupons and the honeycomb compression coupons after 12 months of exposure. The 12-month exposure data are compared to the time-zero data in Figures 115 and 116. These results indicate a slight increase in strength for both specimen configurations.

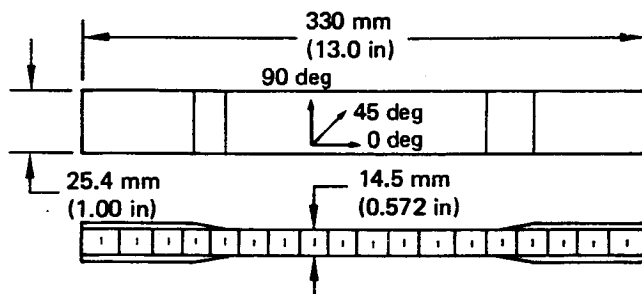
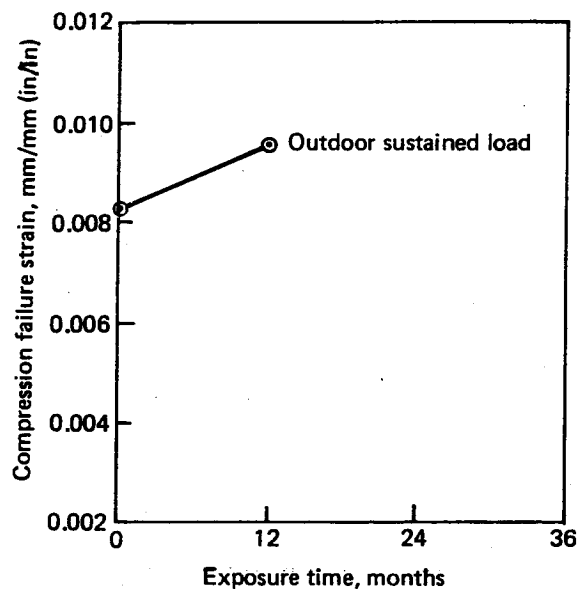
Figure 116. Honeycomb Compression Coupon Environmental Exposure Test Results

- Face sheets: 1-ply tape, 1-ply fabric
- Orientation:
 - Tape: 90 deg
 - Fabric: ± 45 deg
- Extensional modulus, 2.62×10^4 MPa (3.8×10^6 lbf/in²)
- Data from NASA Test 3, Appendix C

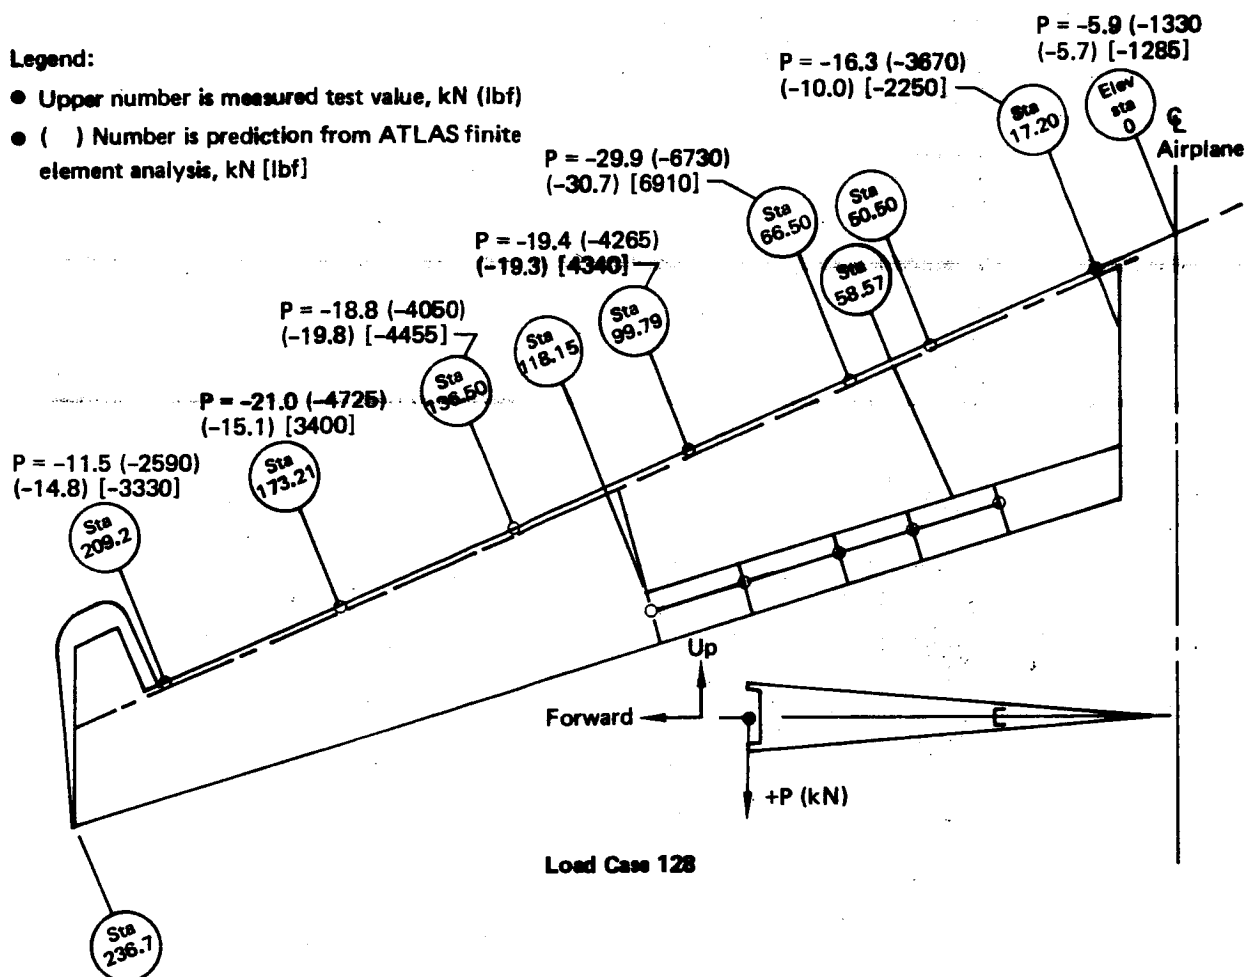
Figure 127. Hinge-Load Ultimate Loads—Predicted Versus Test

- Upper number is measured test value, kN (lbf)
- () Number is prediction from ATLAS finite element analysis, kN [lbf]

Figure 127 shows the hinge and actuator ultimate loads, predicted versus test, for LC 128.
